HYDROGEN & SYN GAS TECHNICAL TRAINING SEMNAR

FAILURE MECHANISMS & INSPECTION TECHNIQUES IN STEAM METHANE REFORMERS

NOVEMBER 28TH - 30TH, 2023

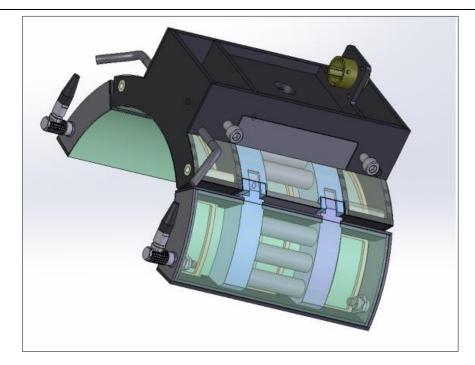
ID ROTATING PROBE 360° COVERAGE

360° EDDY CURRENT PROBE COVERAGE OF THE REFORMER TUBE OD

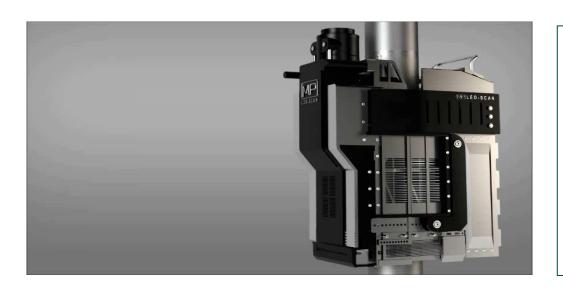
<u>LEO - SCAN (Laser Eddy Current Outside Scanning of Reformer Tubes)</u>

- > Proven, Accurate and Reliable
- ➤ EC probes penetrate up to 23.5 mm
- Dual axis laser measurement
- Starting point is 20 mm from the floor
- ➤ High Speed 250 tubes / shift
- > Inspection with or without catalyst

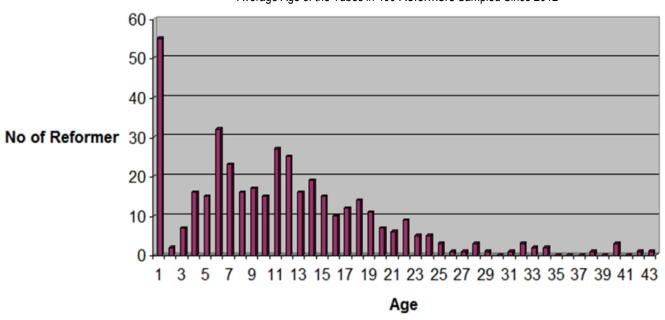
Average Age of the Tubes in 400 Reformers Sampled Since 2012

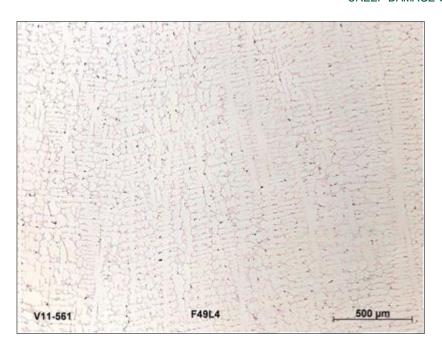
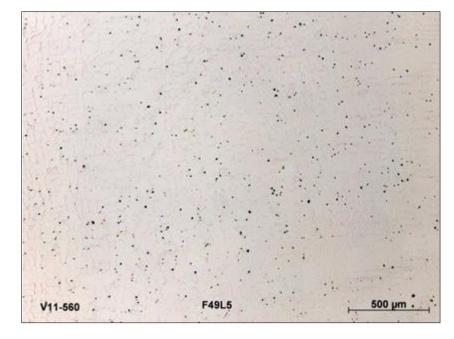
CREEP CLASSIFICATION - CREEP DAMAGE (BLACK SPOTS) - CLASS 2A

Class 2A : Isolated cavities;

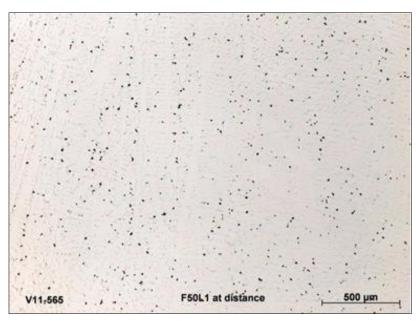
CREEP CLASSIFICATION - CREEP DAMAGE (BLACK SPOTS) - CLASS 2B

Class 2B : Numerous cavities without preferred orientation;

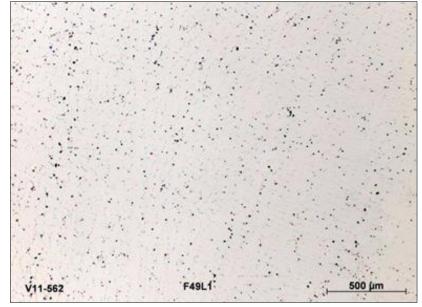
CREEP CLASSIFICATION - CREEP DAMAGE (BLACK SPOTS) - CLASS 3A

Class 3A : Numerous oriented cavities;

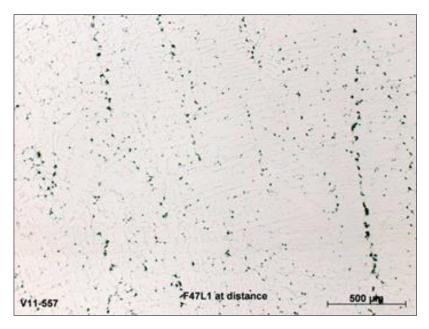
CREEP CLASSIFICATION - ALIGNED CAVITIES, MICRO CRACKS - CLASS 3B - 4

Class 3B : Chains of cavities and/or grain boundary separations;

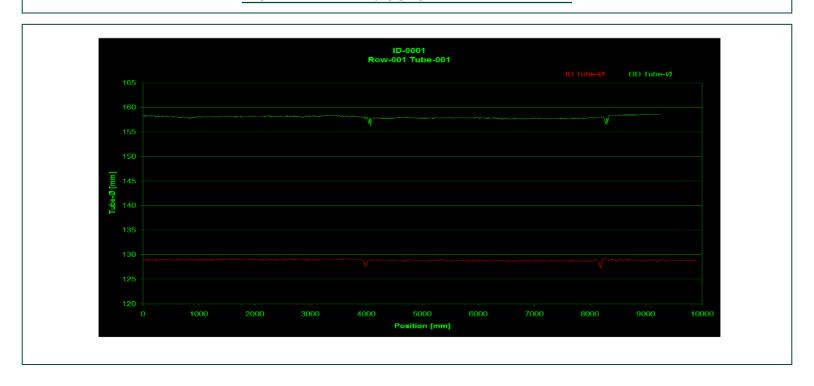
SEVERAL INSPECTIONS OVERLAYED - NO DAMAGE

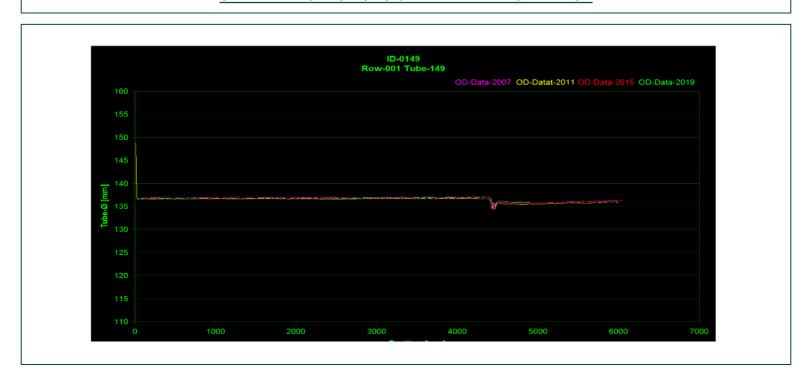
SEVERAL INSPECTIONS OVERLAYED - DAMAGE OBSERVED

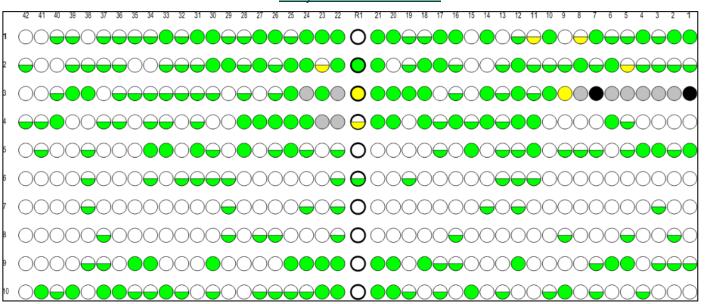
Eddy Current Indications

Co	lor Definit	tion	
#	Colors	Cracks	Expansions
1		no indication	0 - 0.4%
2		small indication	0.5 - 0.9%
3		30%	1.0 - 1.4%
4		35%	1.5 - 1.9%
5		40%	2.0 - 2.4%
6		45%	2.5 - 3.0%
7		50%	3.0 - 3.5%
8		> 50%	> 3.5%
9		open crack	open crack
10		not inspected	not inspected

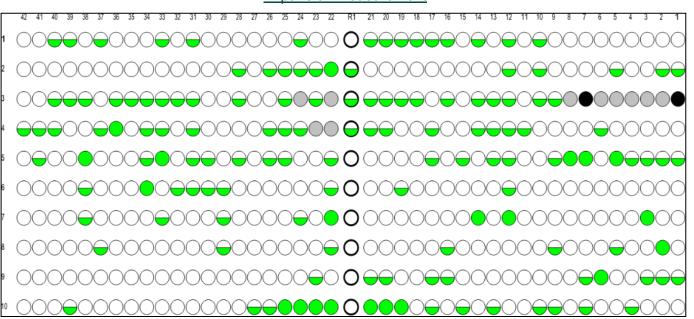
Expansion Measurement

#	Colors	Cracks	Expansions
1		no indication	0 - 0.4%
2		small indication	0.5 - 0.9%
3		30%	1.0 - 1.4%
4		35%	1.5 - 1.9%
5		40%	2.0 - 2.4%
6		45%	2.5 - 3.0%
7		50%	3.0 - 3.5%
8		> 50%	> 3.5%
9		open crack	open crack
10		not inspected	not inspected
