Root cause analysis of poor performance in nitric acid plants

J. Ashcroft, R. Lopez-Garcia and I. Hepplewhite

Reprinted from Nitrogen and Syngas Conf, Hague, 2020

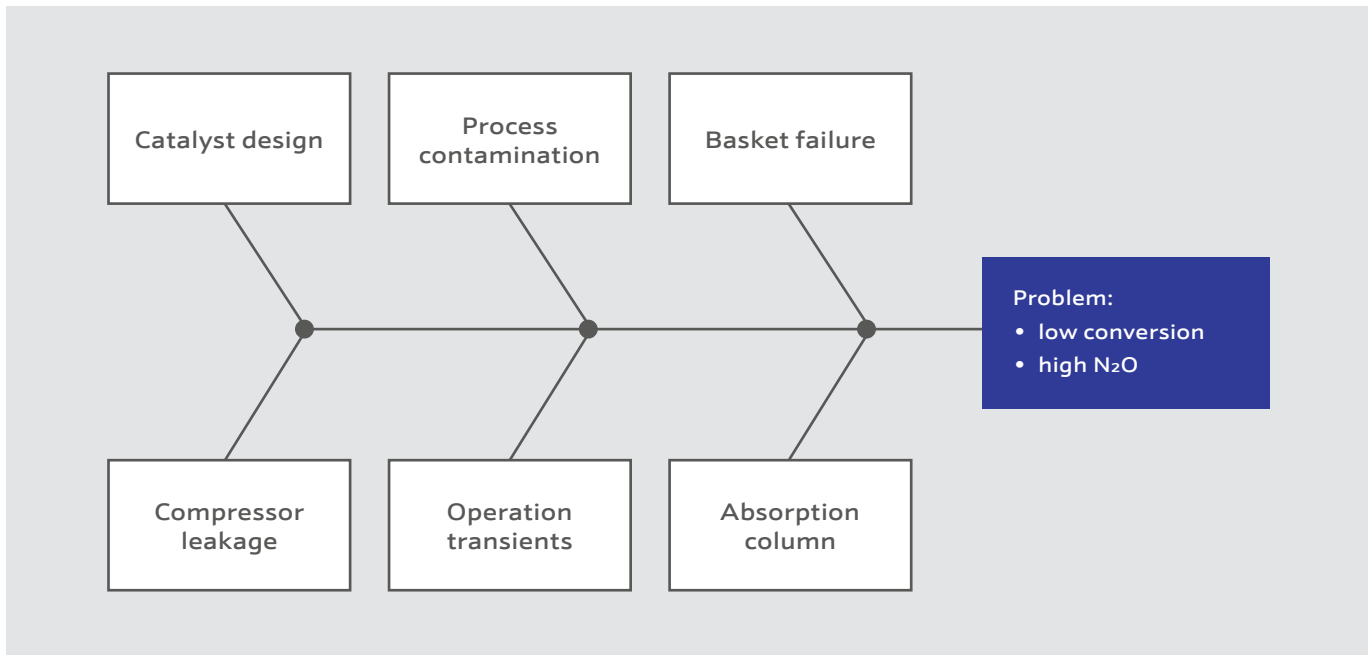
Fig. 1: The main factors considered during the root cause analysis

The team that carried out the root cause analysis was a team of engineers from both the customer plant and JM. Initially, an exhaustive list of potential factors that could have an impact on plant efficiency were listed. This list was then reviewed by the team of engineers and several factors could be ruled out. The main factors considered for the majority of these case studies are summarised in Fig. 1. The team at the customer plant and at JM were then both given tasks to rule out certain hypotheses.

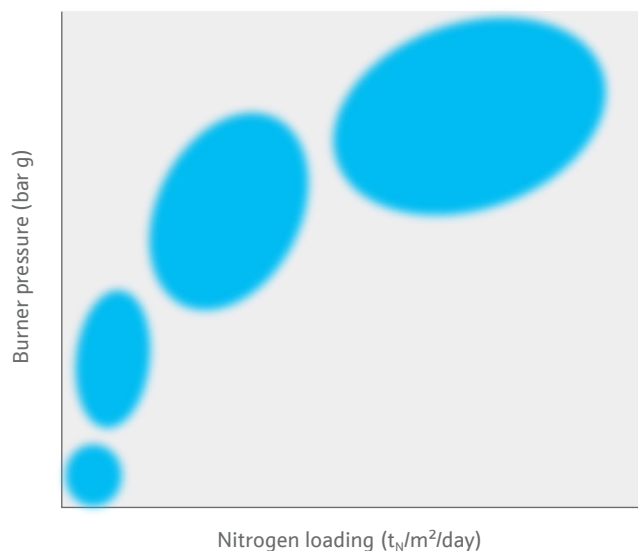
Fig. 2: Four plant operating ranges demonstrated in terms of nitrogen loading and burner pressure

When designing catalyst packs, JM considers the plant operating conditions and campaign requirements to design a pack with a competitive PGM weight that will deliver high performance throughout the campaign. The design rules applicable vary depending on the plant type, with four plant categories covering almost all operating conditions (see Fig. 2).

For medium pressure plants, operating around 2-6 bar g and with a nitrogen loading of less than 20 tonne N/m²/day, JM designs the catalyst pack using proprietary design tools to generate a highly efficient design whilst minimising the installed metal content. This design utilises high surface area gauze structures in the top layers of the pack, providing sufficient platinum sites to complete the majority of the reaction at the beginning of the campaign in the top two layers of the pack.

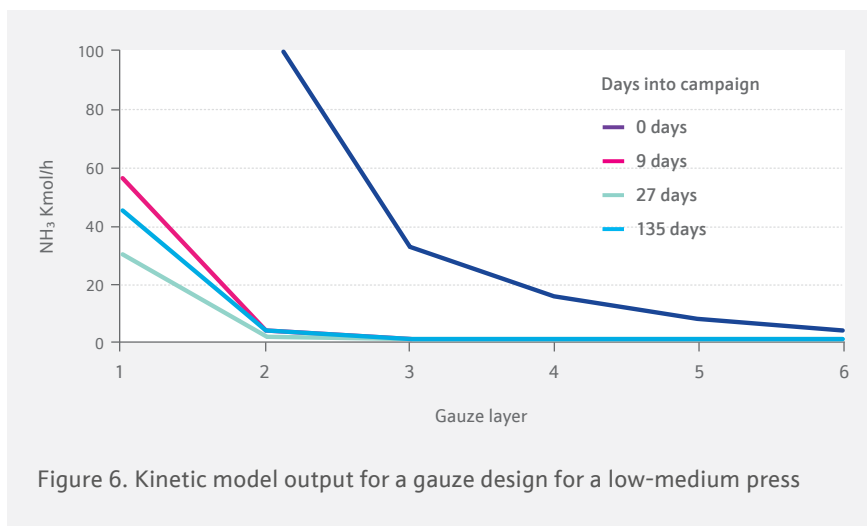
Figure 6. Kinetic model output for a gauze design for a low-medium press

To ensure that the gauze design could not be a contributing factor to any sudden decrease in efficiency, a simulation of the catalyst pack is often run using the ammonia oxidation kinetic model to verify that the ammonia oxidation reaction is completed at the appropriate point within the pack. The case study below was carried out to illustrate the expected reaction profile of a medium pressure plant gauze design at various points within the campaign. The reaction profile modelling carried out during a root cause analysis will vary depending on the category of nitric acid plant and the issues faced by the customer.

During start-up, the gauze wires are flat and have limited surface area, and the reaction is completed within the 6-layer pack. Immediately following a successful light off, the wire surface begins to restructure to form high surface area growth, termed 'cauliflowers', and the bulk of the reaction is expected to complete within the top two layers for a plant with this pressure and nitrogen loading.

The results showed that within one week of operating, over 99% of ammonia had been converted after the second layer of the gauze design. Towards the end of the campaign the top layers would be expected to deactivate as they lose platinum throughout the campaign and the reaction profile would be expected to move further through the pack. By this stage that palladium-based alloys lower in the pack will have collected sufficient platinum to provide catalytic sites to continue providing a high level of performance.
