HYDROGEN & SYN GAS TECHNICAL TRAINING SEMINAR

FAILURE MECHANISMS & INSPECTION TECHNIQUES IN STEAM METHANE REFORMERS

# LATEST DEVELOPMENTS FOR REFORMER TUBE TESTING

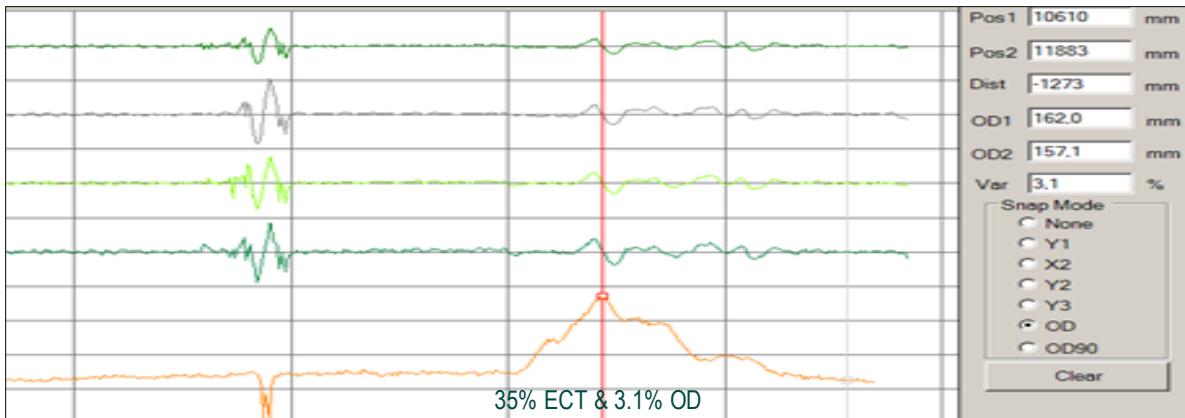
### CRACKING AND EXPANSION CORRELATED AT NORMAL CREEPING

CREEP DAMAGE OCCURS OVER DESIGN LIFE TIMESCALES!

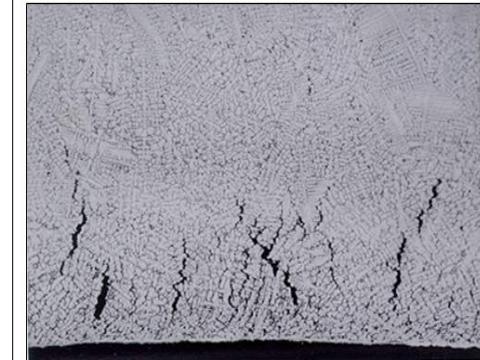
Figure 1. Photomicrograph of creep damage near the ID of Terra tube A-3  
Magnification 25 X      Etchant: Oxalic Acid

- Class 0 : As received, without thermal service load;
- Class 1 : Creep exposed, without cavities;
- Class 2A : Isolated cavities;
- Class 2B : Numerous cavities without preferred orientation;
- Class 3A : Numerous oriented cavities;
- Class 3B : Chains of cavities and/or grain boundary separations;
- Class 4 : Micro cracks;
- Class 5 : Macro cracks.

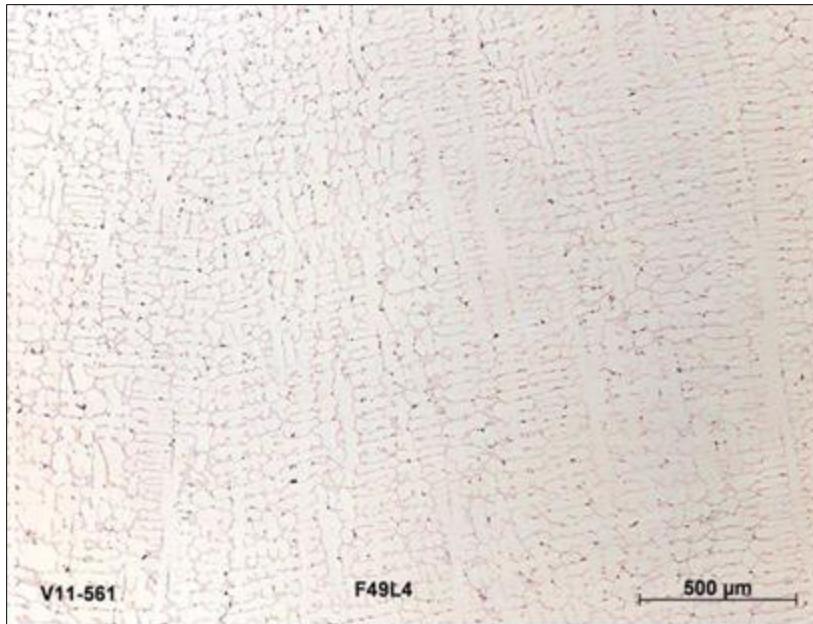
CREEP CLASSIFICATION - NO CREEP DAMAGE - CLASS 1

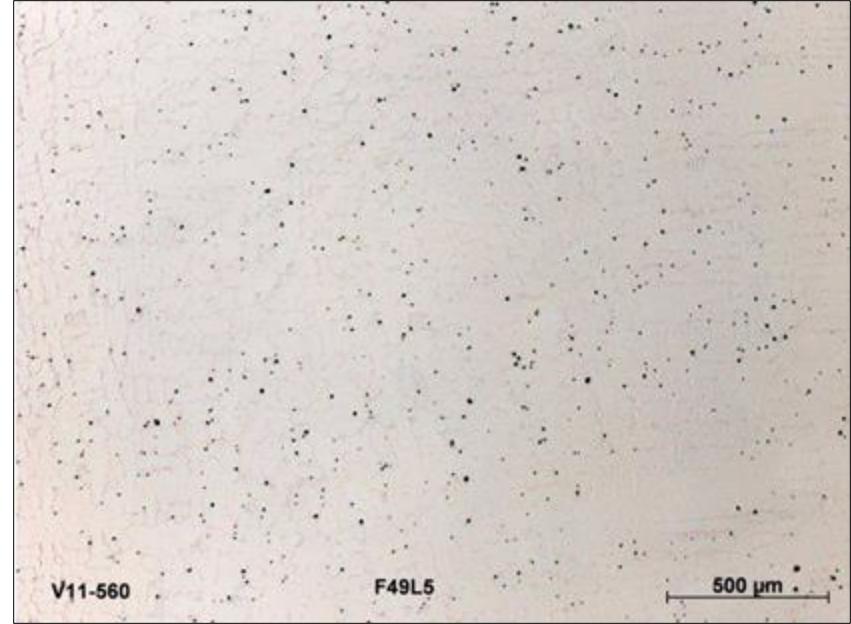
CREEP CLASSIFICATION – CREEP DAMAGE (BLACK SPOTS) - CLASS 2A

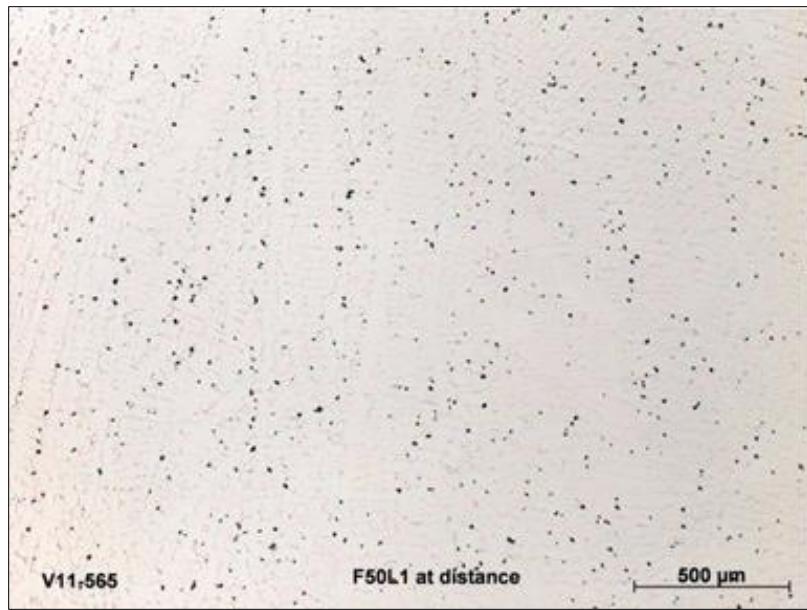
CREEP CLASSIFICATION - CREEP DAMAGE (BLACK SPOTS) - CLASS 2B

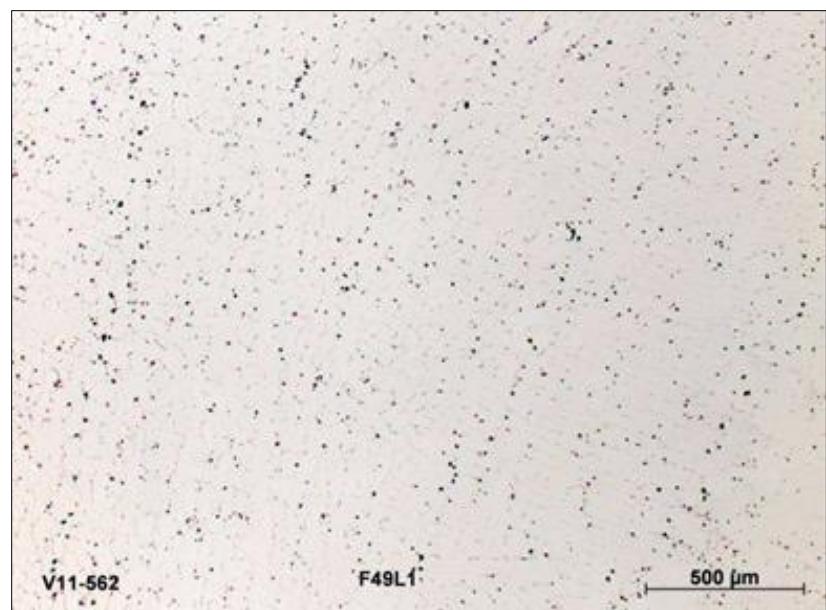
CREEP CLASSIFICATION - CREEP DAMAGE (BLACK SPOTS) - CLASS 3A

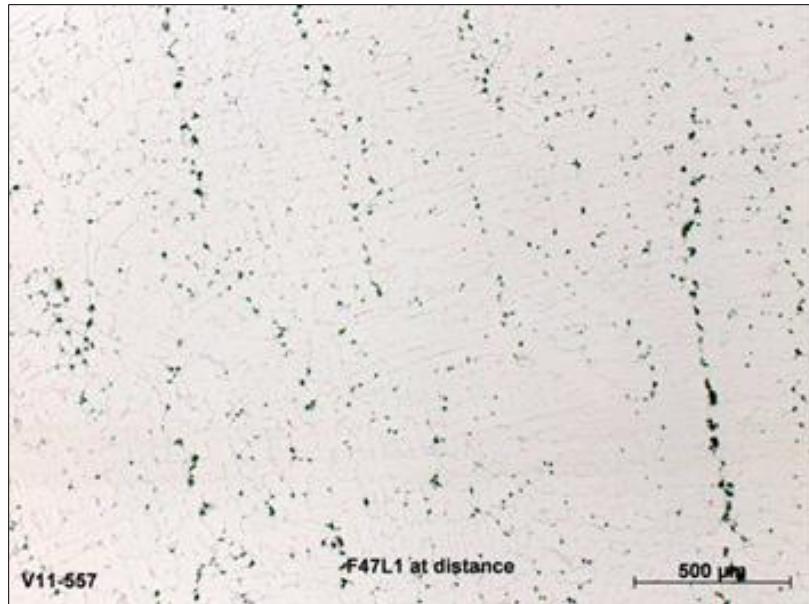
CREEP CLASSIFICATION - ALIGNED CAVITIES, MICRO CRACKS - CLASS 3B - 4

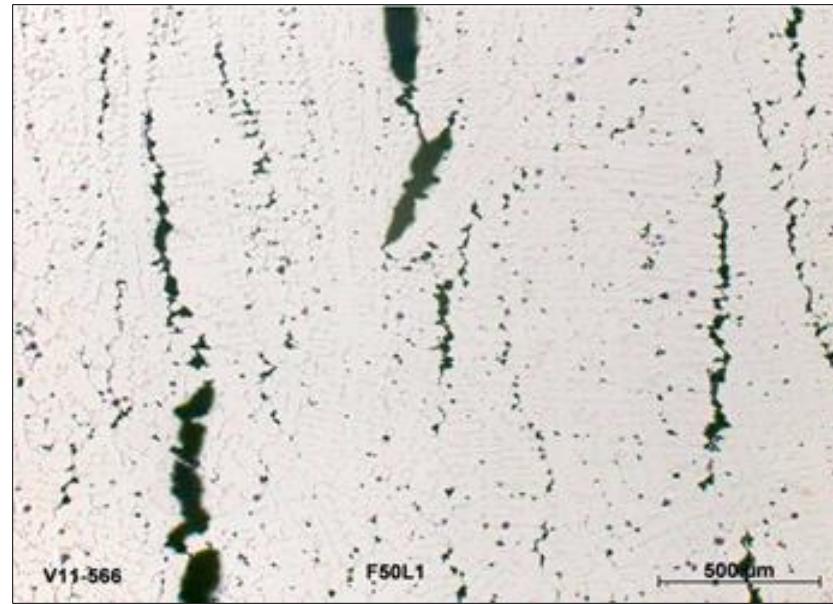
CREEP CLASSIFICATION - MACRO (OPEN) CRACKS - CLASS 5

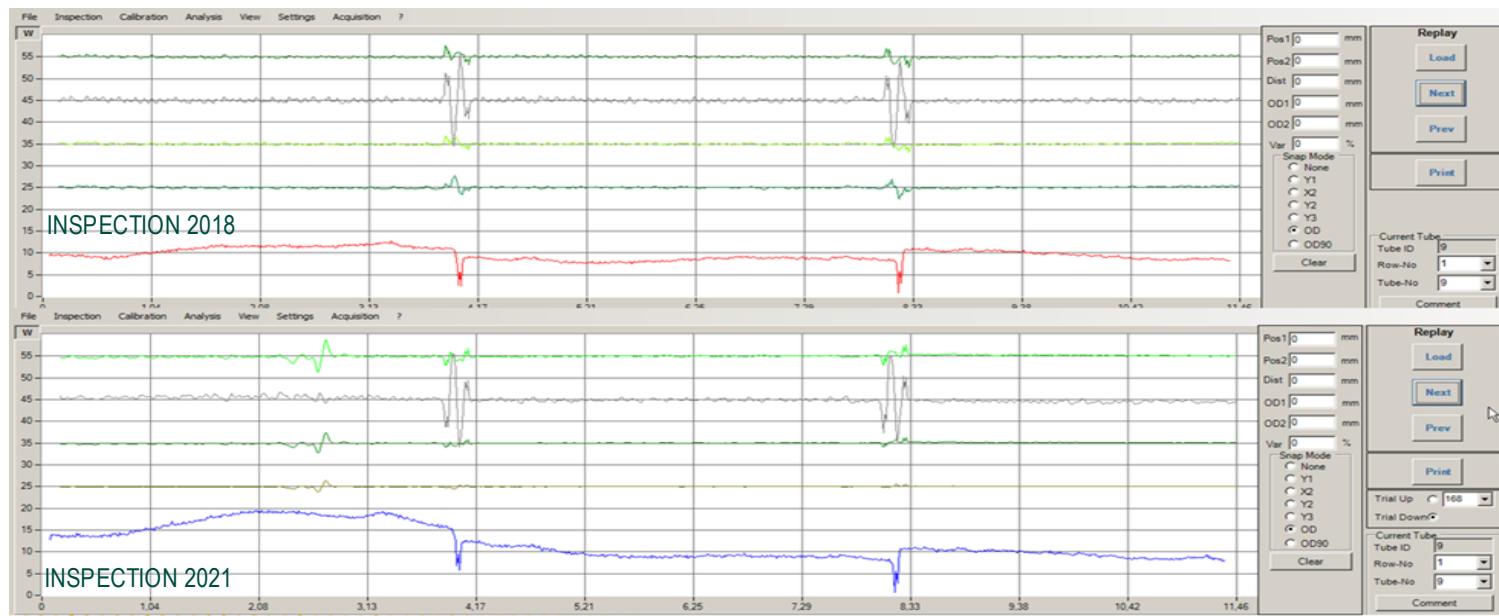
### CRACKING & EXPANSION CORRELATED AT NORMAL CREEPING

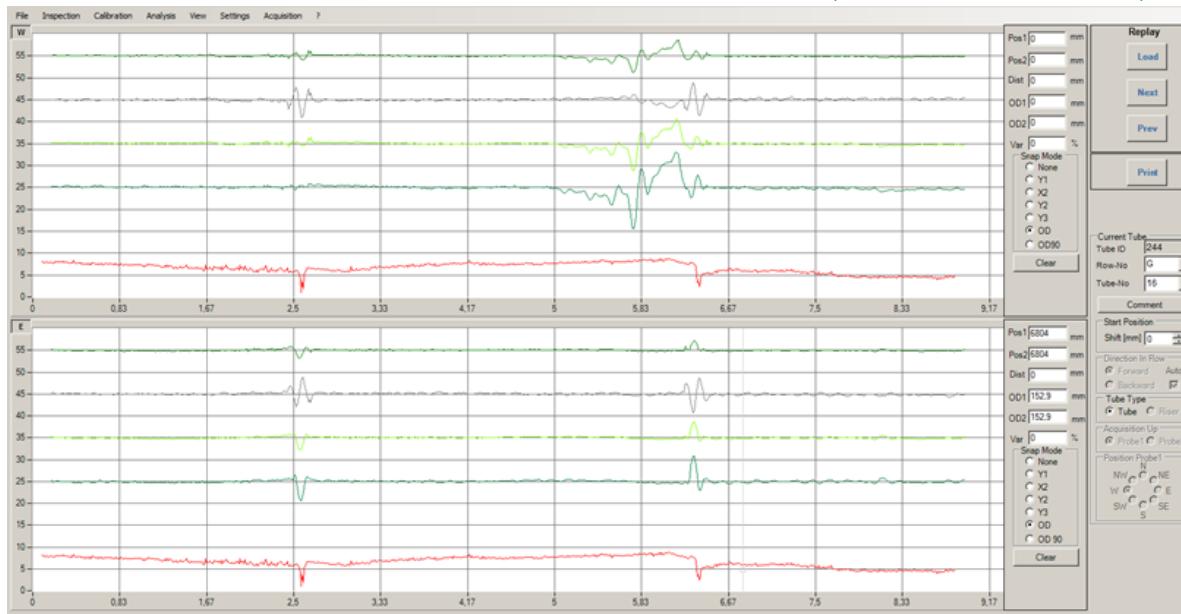
CRACKING WITH LITTLE OR NO EXPANSION (EXAMPLE: THERMAL SHOCK)

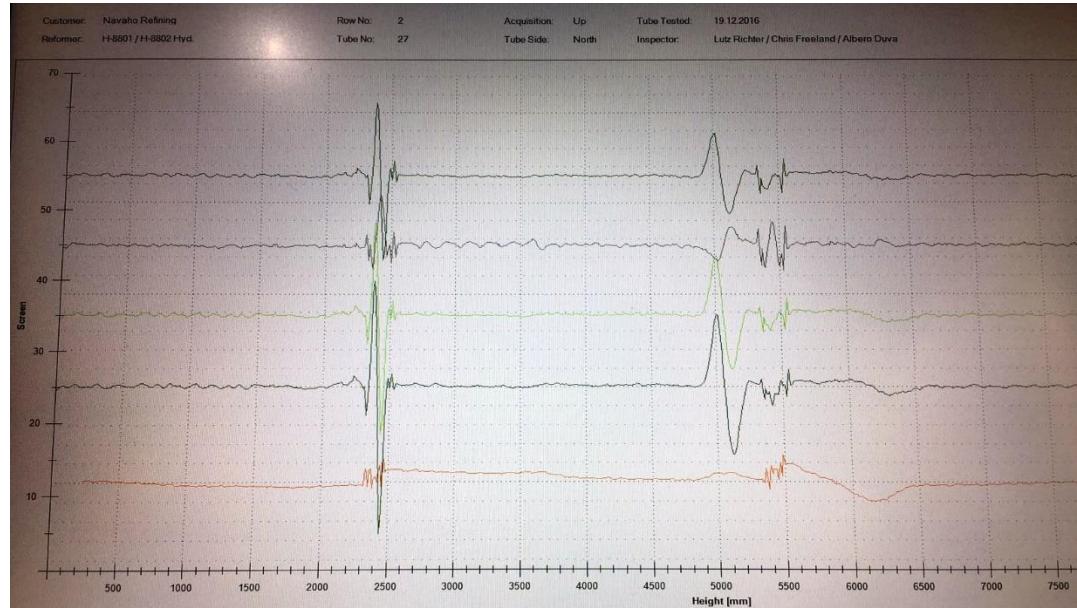
Little or No Expansion with Significant Cracking

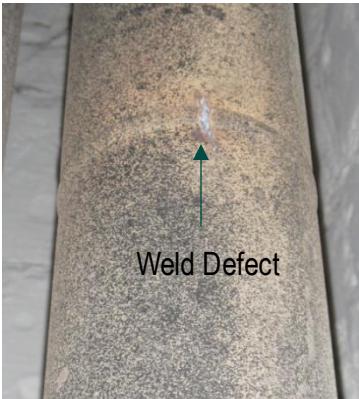
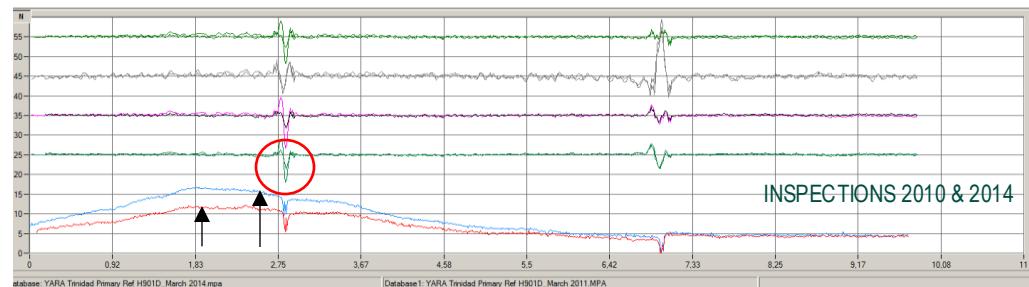
LONGITUDINAL WELD DEFECTS

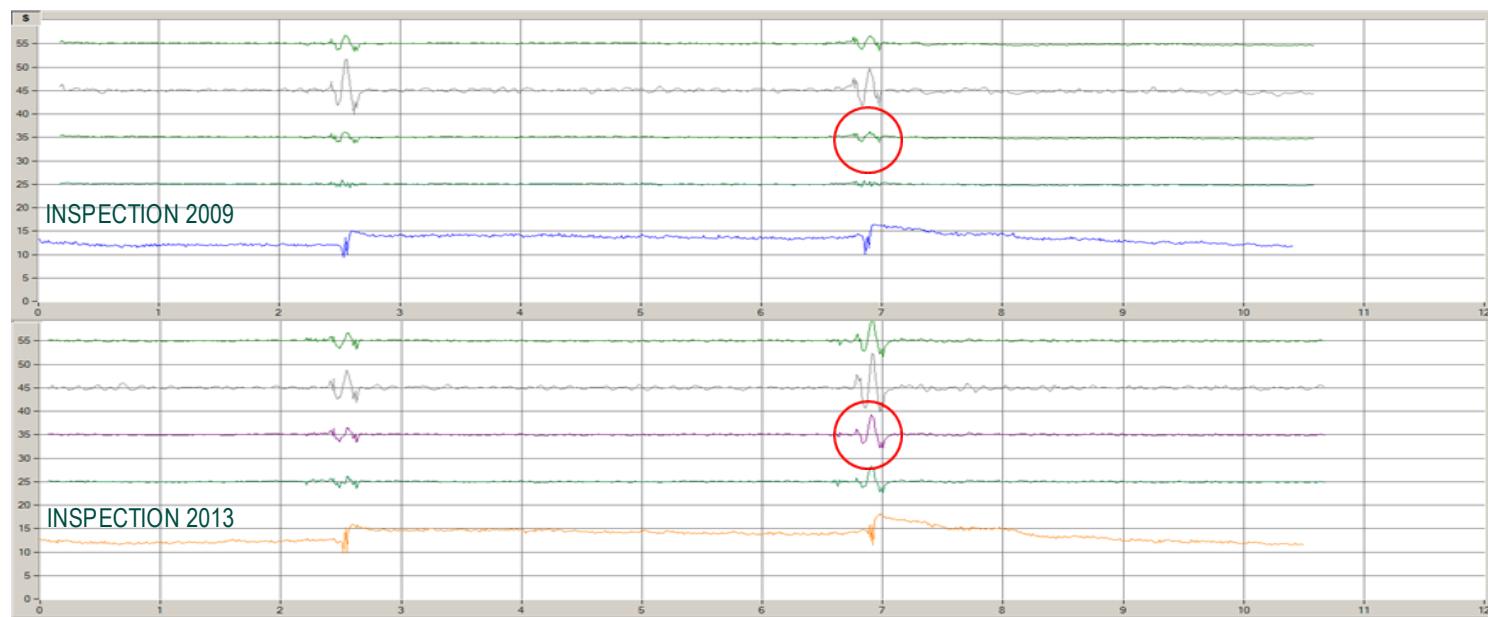
CIRCUMFERENTIAL WELD DEFECTS

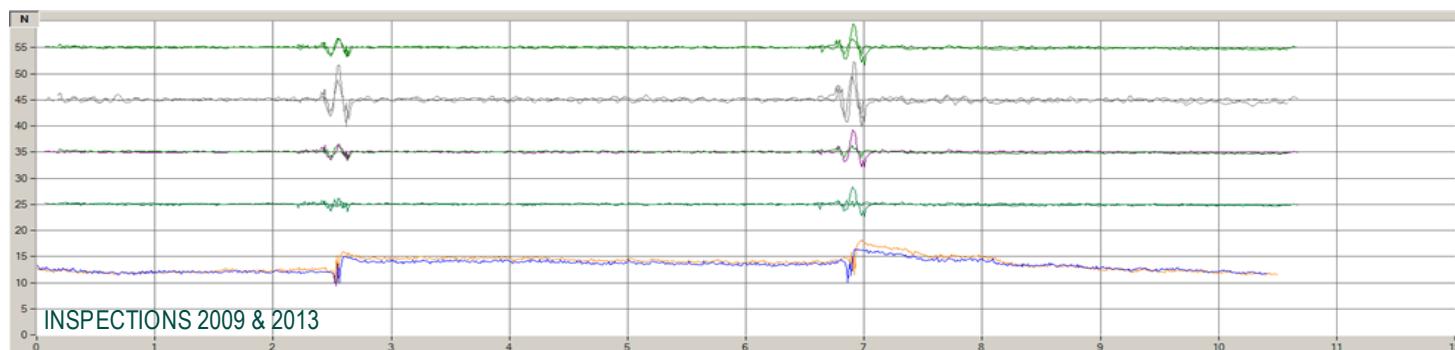
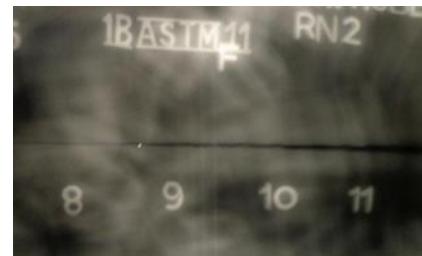
CIRCUMFERENTIAL WELD DEFECTS

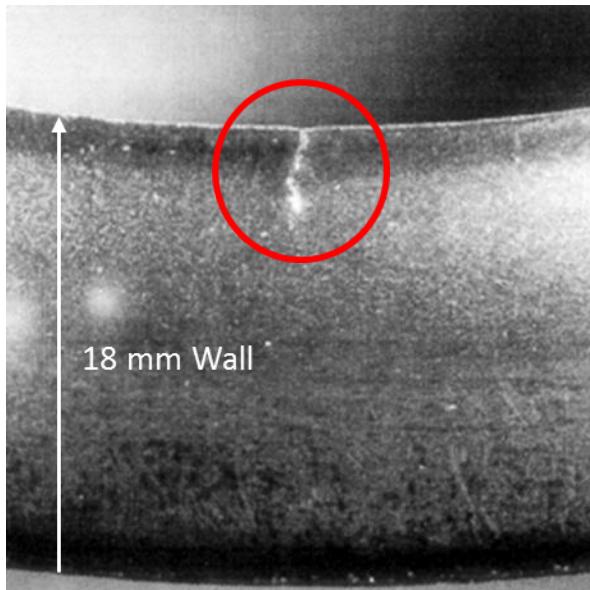
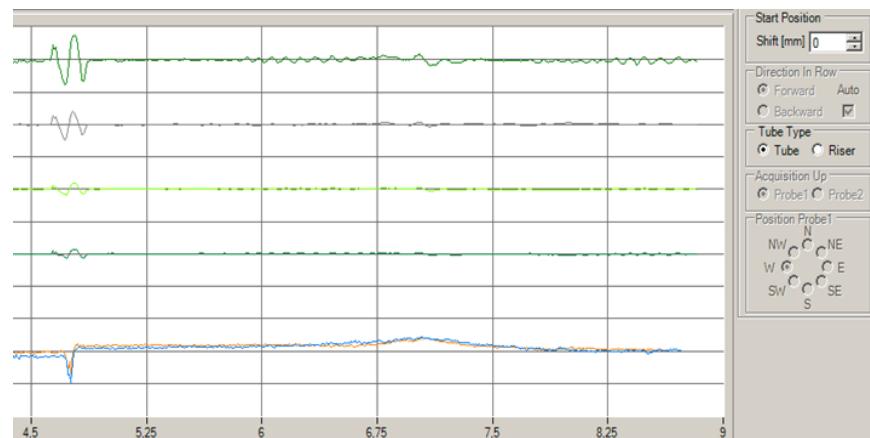
DEFECTS CLOSE TO THE INSIDE DIAMETER (ID)

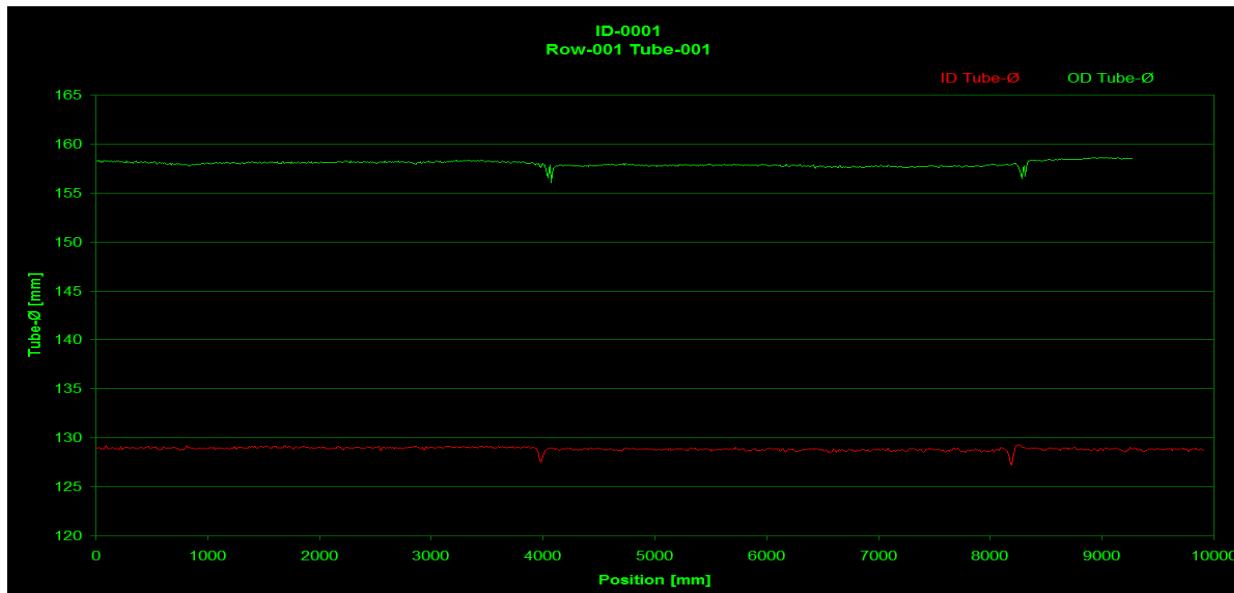
### INSIDE DIAMETER / OUTSIDE DIAMETER DATA

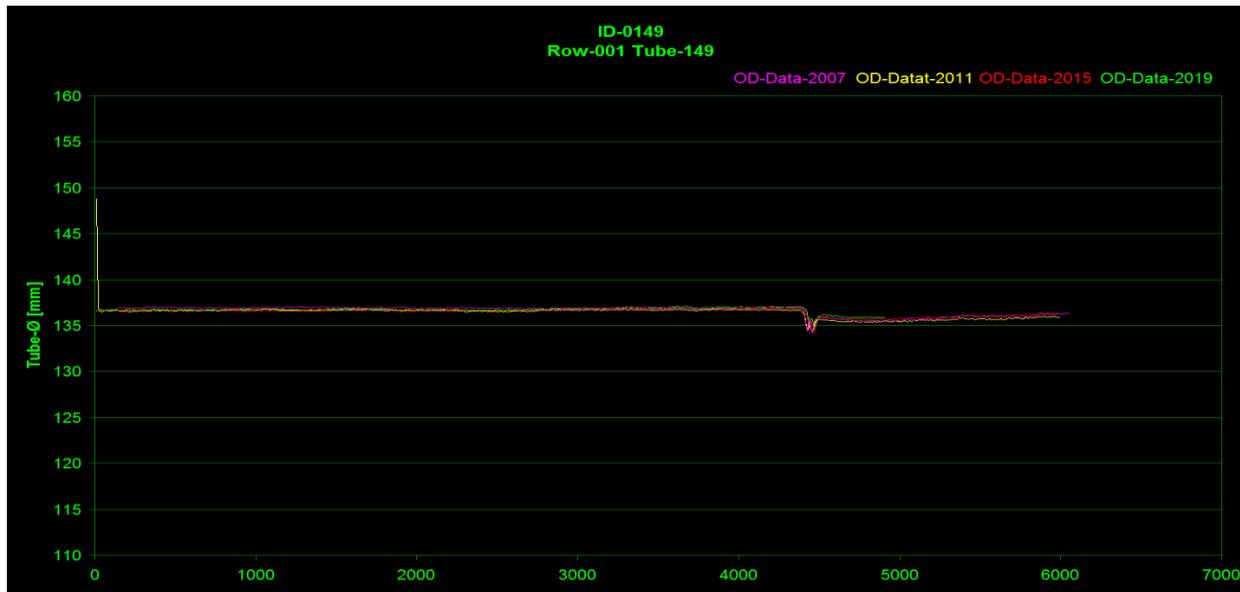
SEVERAL INSPECTIONS OVERLAYED - NO DAMAGE

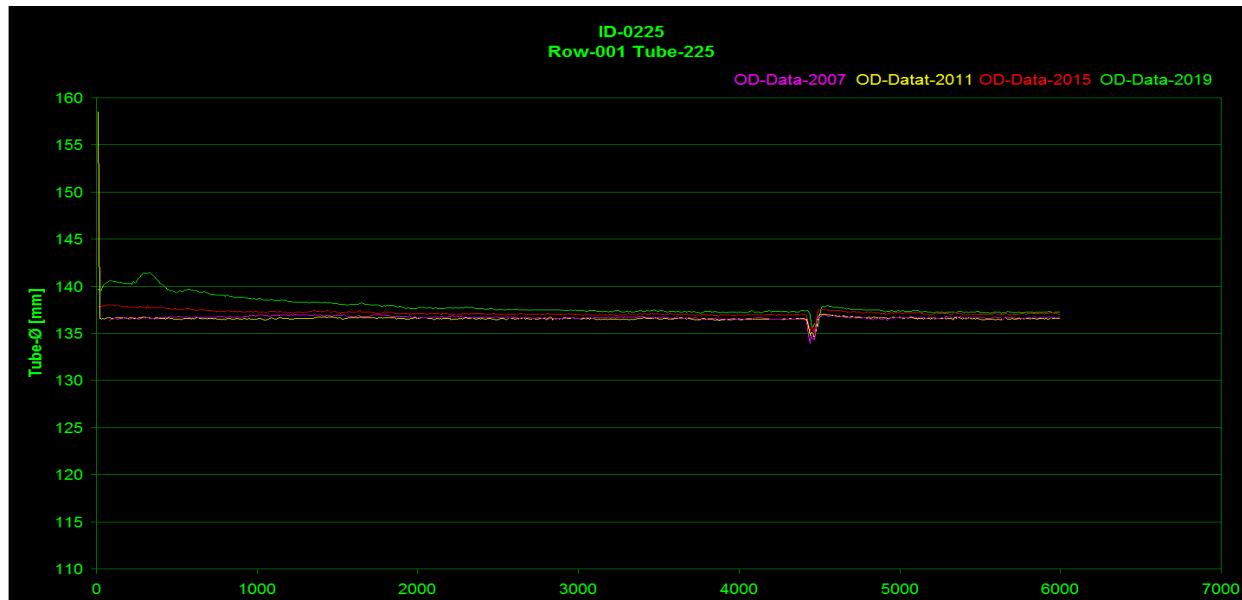
SEVERAL INSPECTIONS OVERLAYED - DAMAGE OBSERVED

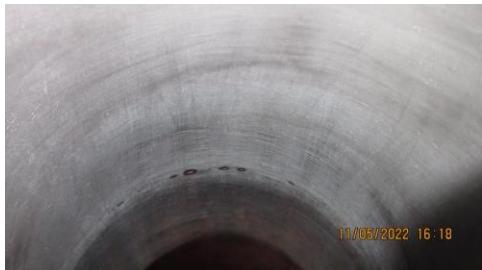
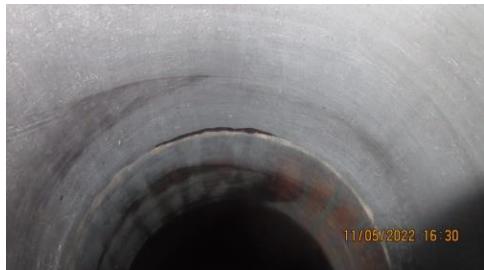
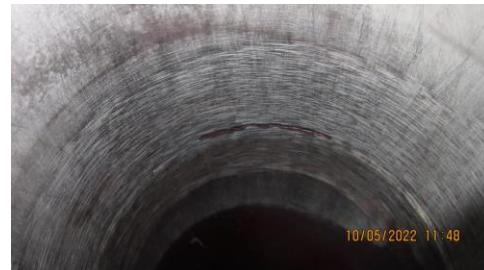
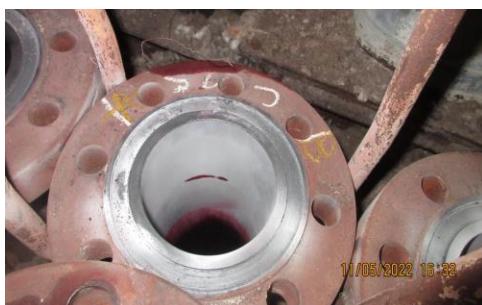
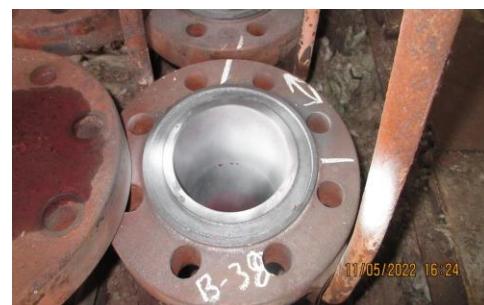
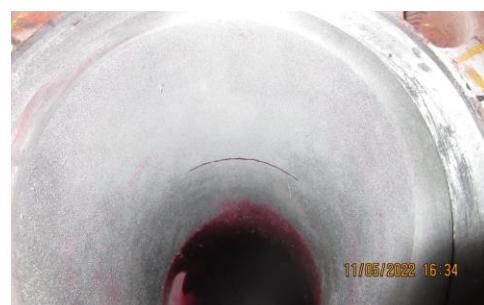
Manufacturing Anomalies

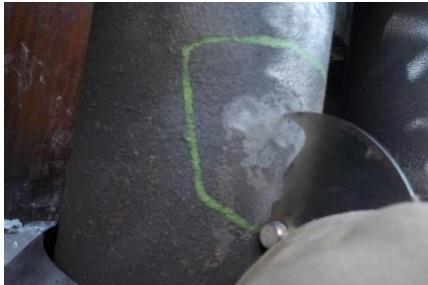
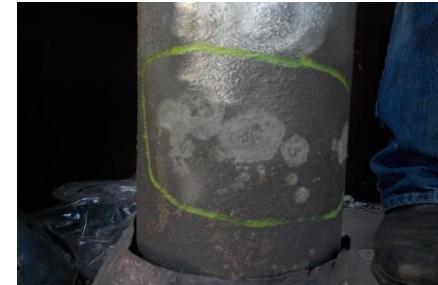
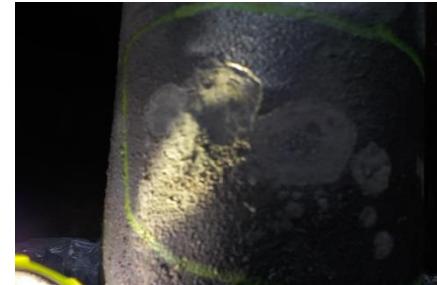
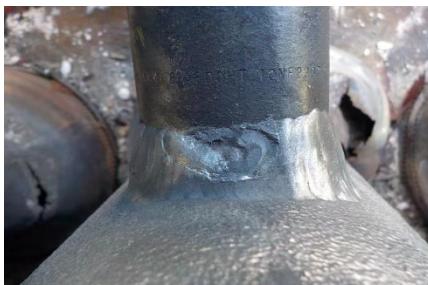
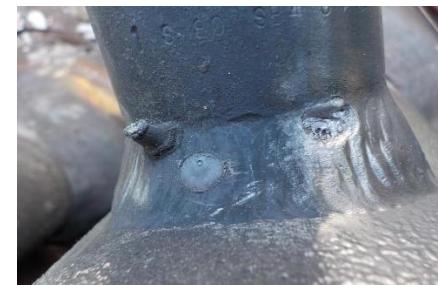
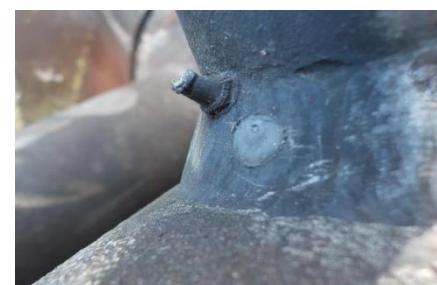
Outlet Pigtail Damage

In Service Damage

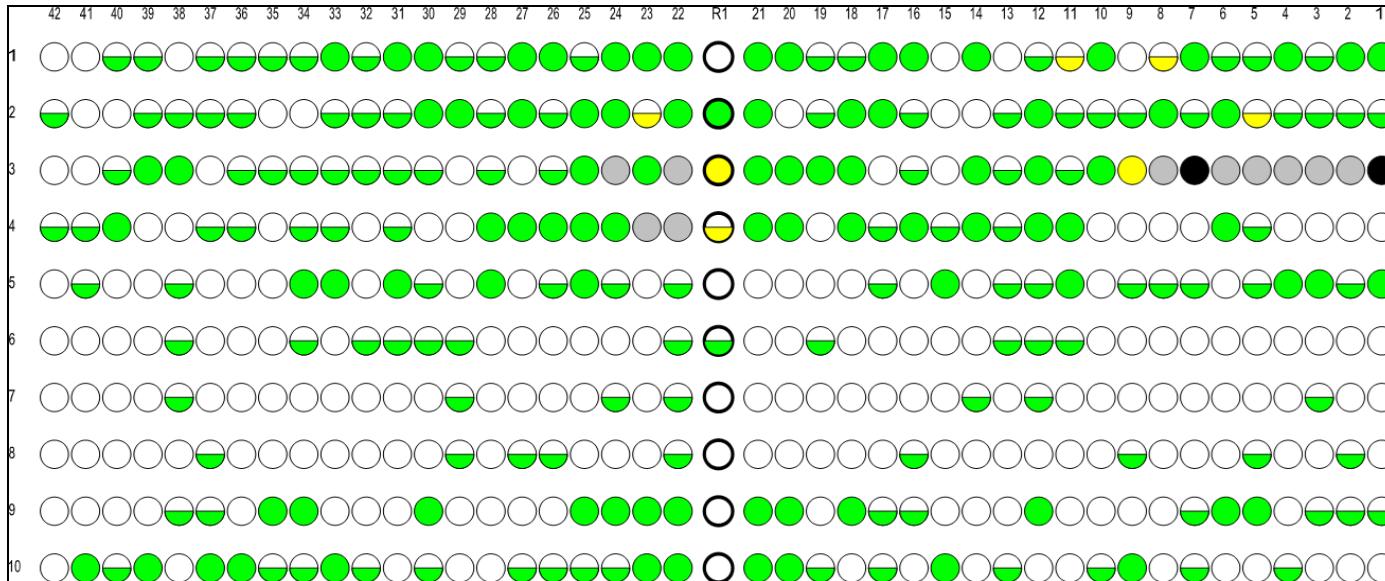
### Eddy Current Indications

Color Definition		
# Colors	Cracks	Expansions
1	no indication	0 - 0.4%
2	small indication	0.5 - 0.9%
3	30%	1.0 - 1.4%
4	35%	1.5 - 1.9%
5	40%	2.0 - 2.4%
6	45%	2.5 - 3.0%
7	50%	3.0 - 3.5%
8	> 50%	> 3.5%
9	open crack	open crack
10	not inspected	not inspected
